NACA RM E54K23

AN EXPERIMENTAL EVALUATION OF SEVERAL DESIGN
VARIATIONS OF HOLLOW TURBINE BLADES FOR
EXPENDABLE ENGINE APPLICATION

By W. C. Morgan and R. H. Kemp

February 23, 1955

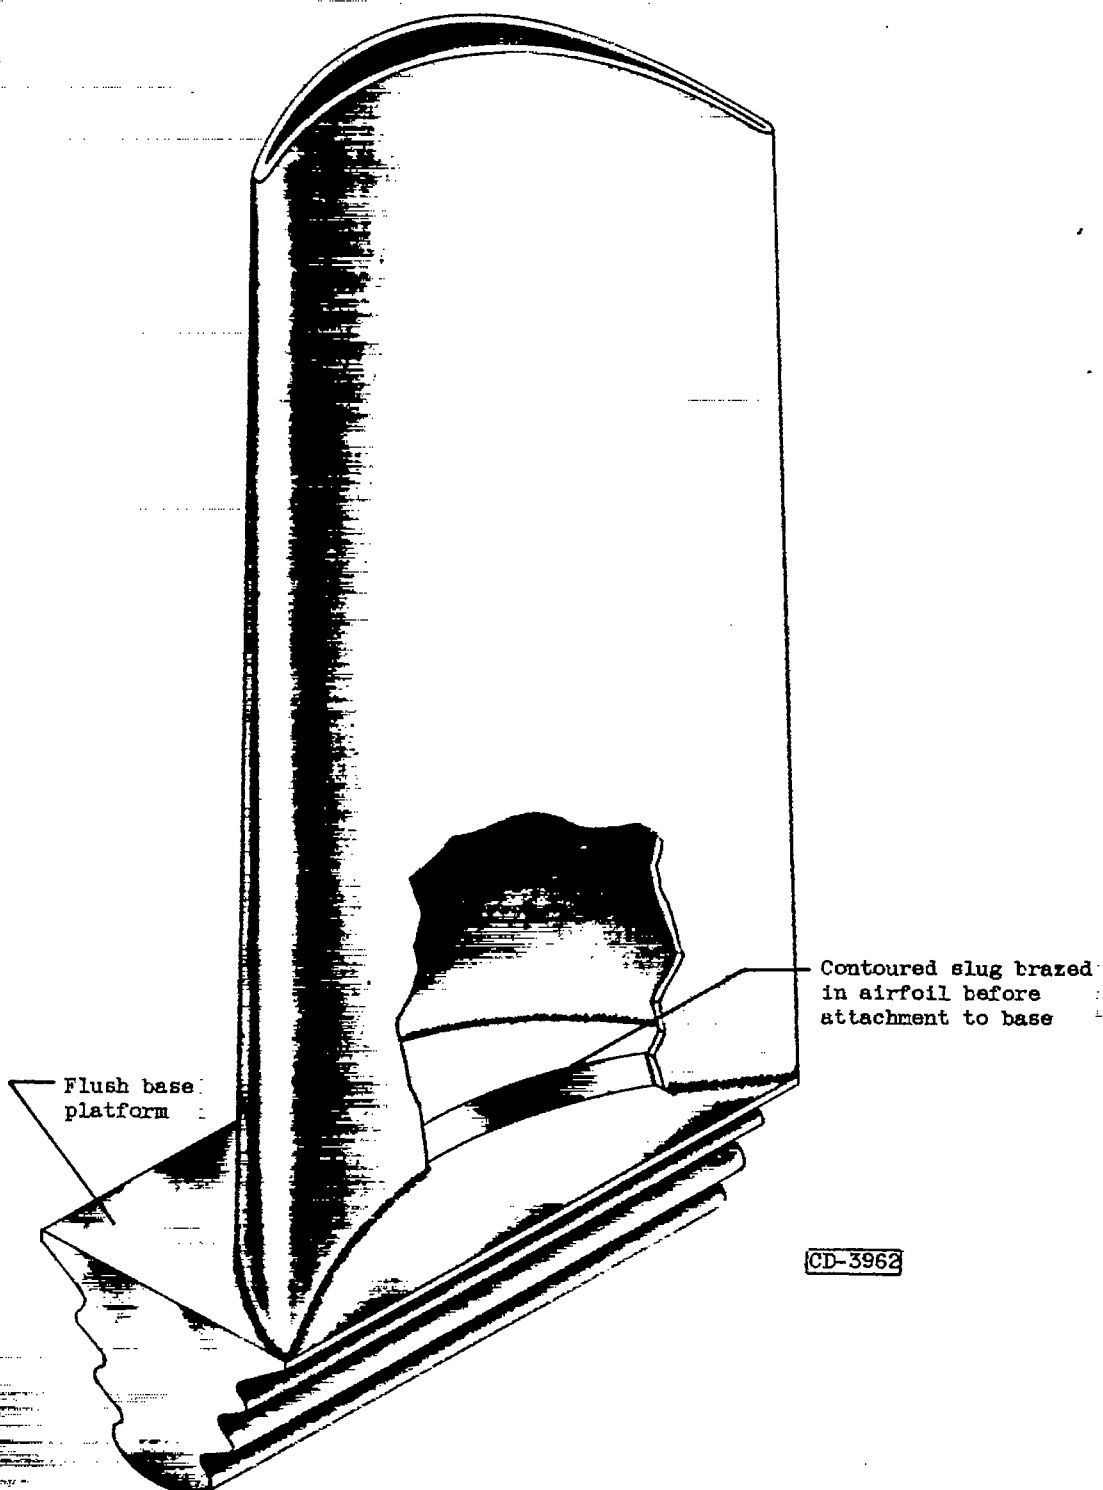
Group 7. - (L-605, 0.030-in. wall, welded airfoil brazed to flush platform as shown in fig. 4, fig. 3, base C.) The three specimen blades were intact at the end of 30 hours of operation. The results indicated that it would be practical to use a brazed joint in tension for the base attachment.

Figure 4. - Construction of sheet-metal airfoil brazed to flush base platform.

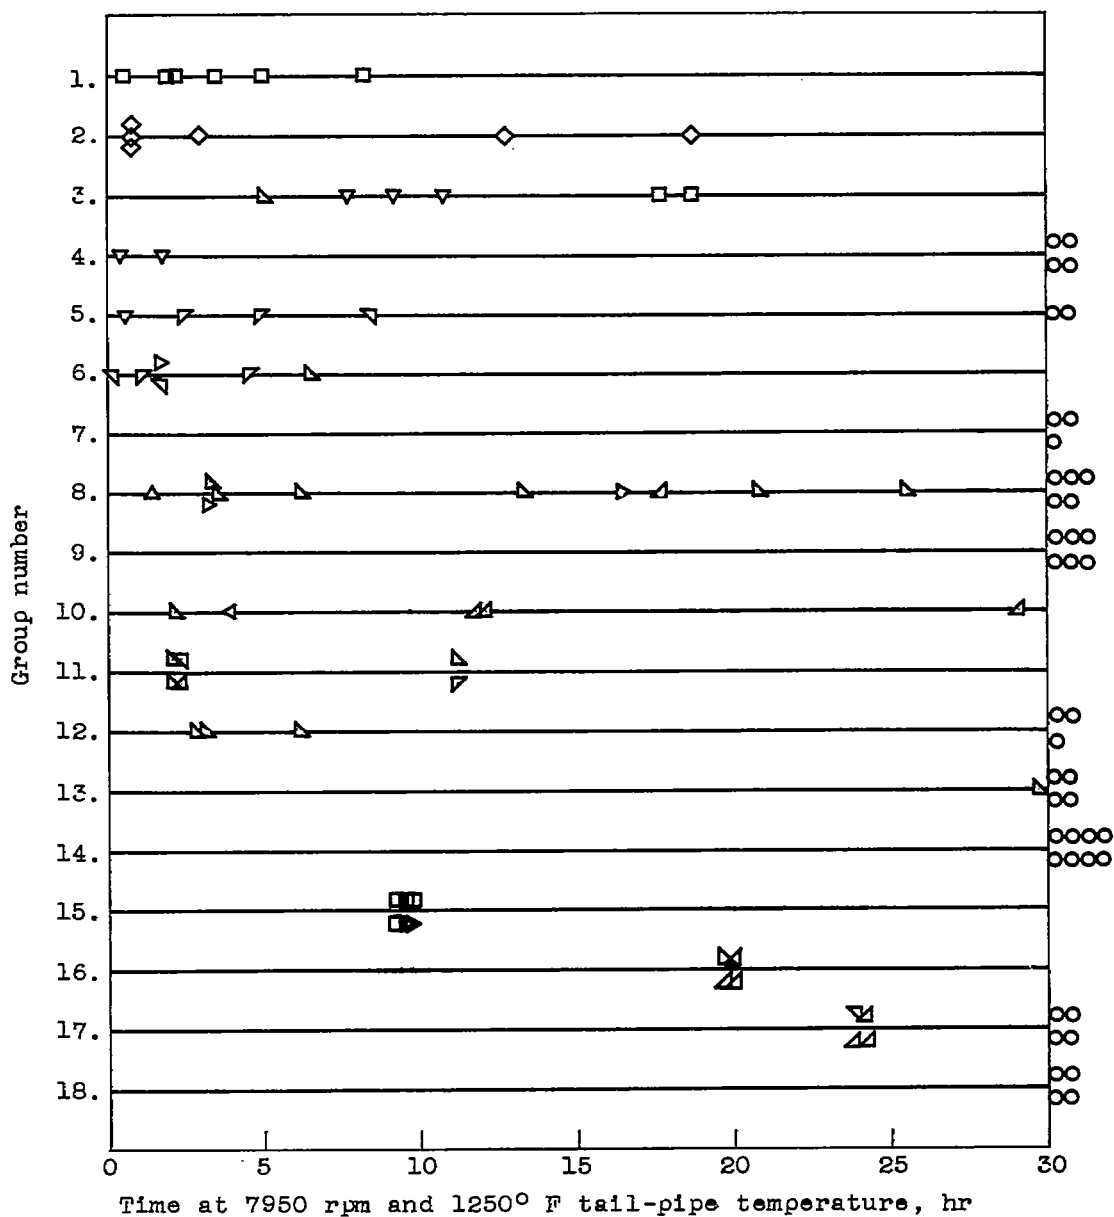
- Completed 30 hours
- Root serration failure
- ◇ Failure in welded attachment at base
- ▽ Failure in brazed attachment at base
- ▽ Failure in airfoil near base
- ▽ Failure in airfoil near midsection
- ▽ Failure in airfoil near tip
- ▽ Cracks in leading or trailing edge
- ▽ Cracks in tip
- ▽ Failure caused by improper fabrication
- △ Failure from impact damage

Figure 8. - Results of engine operation of 18 hollow-blade design variations.
